## **ARBORIST REPORT-Tree/Site Report**

45 West Dunne Ave Morgan Hill CA 95037

Gera-Dunne Project Team

**Mighty Tree Movers Inc.**

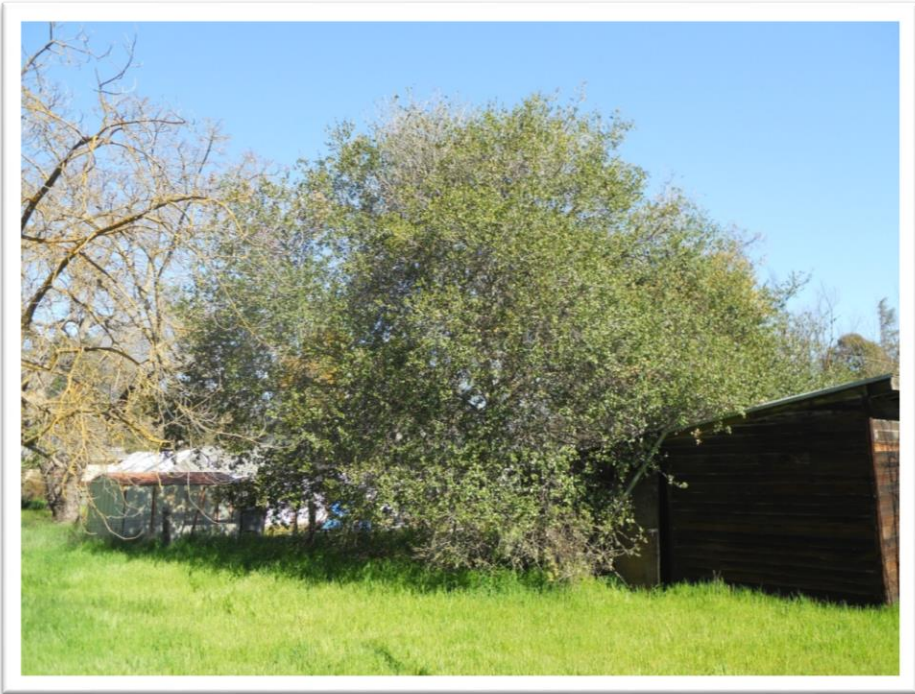
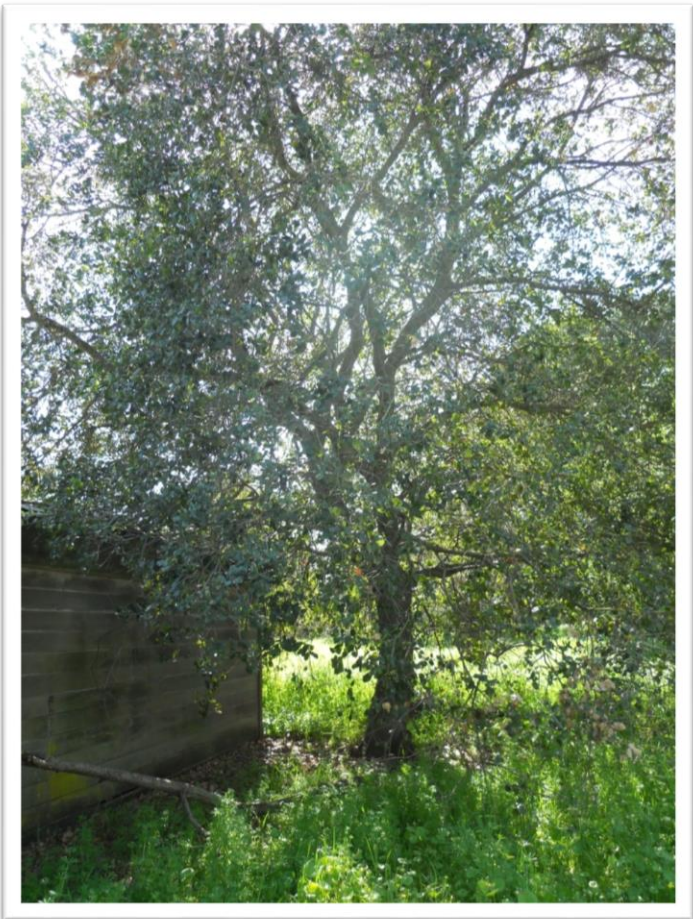
**Tree# 9 Removal**

- (2) Coast live oaks (Trees #4 & 9) are in proposed locations for homes and will need to be removed to allow building as proposed.

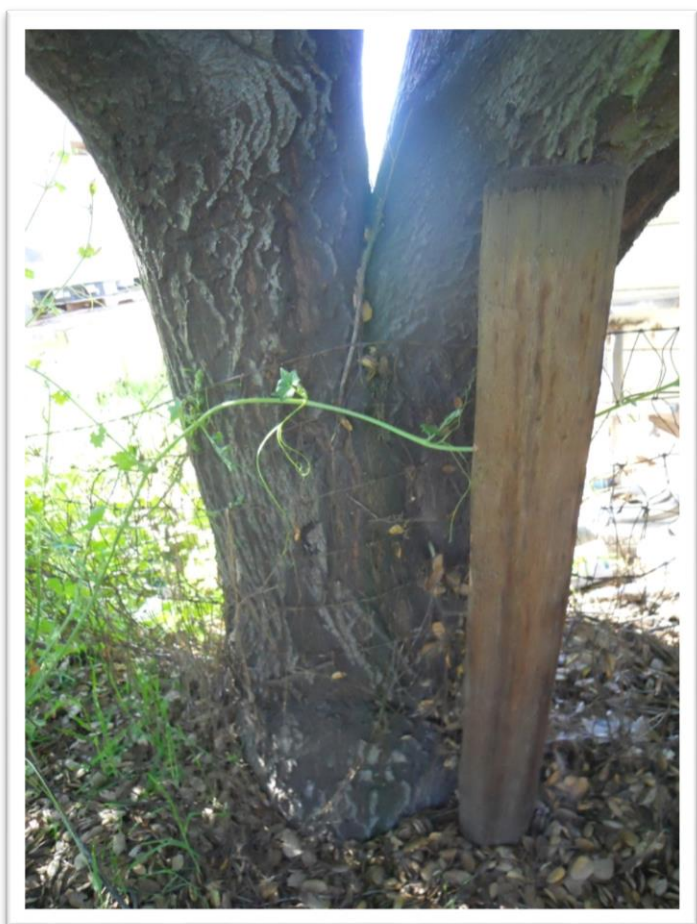
**Tree#4 –Included bark & co-dominant stems**

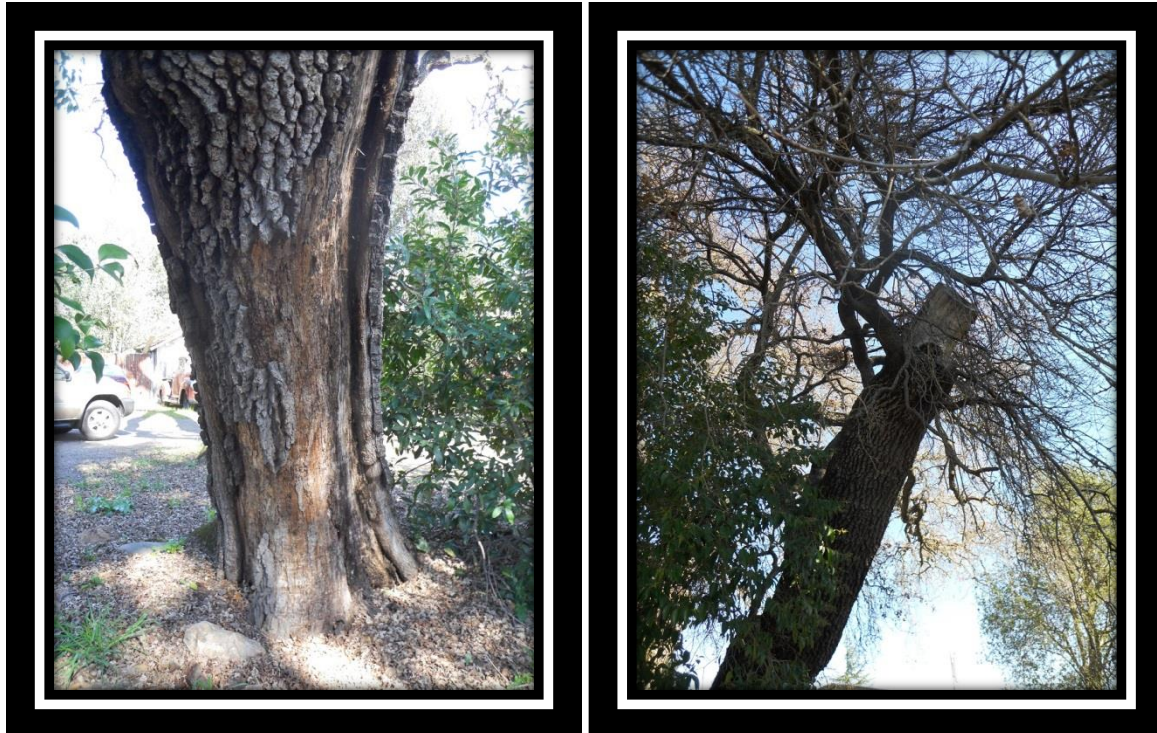
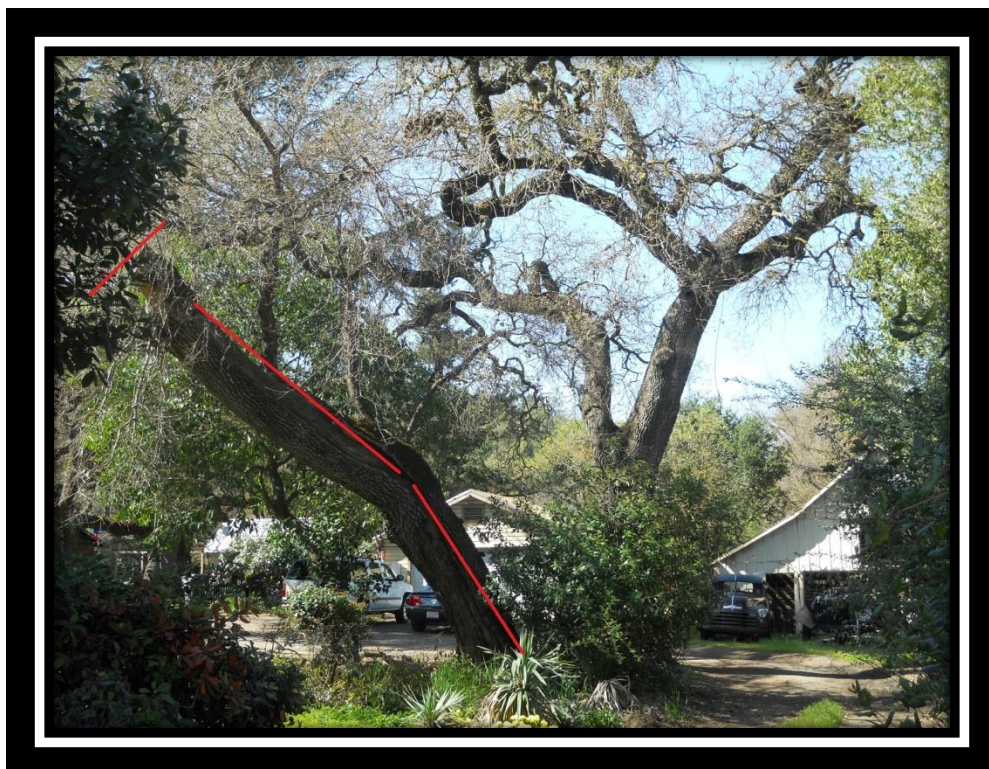
- (1) 100% dead redwood behind existing house on western side of property (Tree#3)
- (1) damaged and leaning Valley oak (Tree #19) \*This tree has heavy damage on trunk, with estimated more than 25% dead wood at the base. This tree also has a very evident lean due to phototropism, or growing under its' parent Valley oak tree. The tree suffered past damage and currently has an insignificant canopy, with poor structure, that adds nothing to the property or tree canopy footprint. This tree is a hazard based on current condition and should be removed regardless of any development.
- Many small volunteer fruit and nut trees along perimeter to be removed.

**Tree#19 Valley oak-remove Hazard Tree**

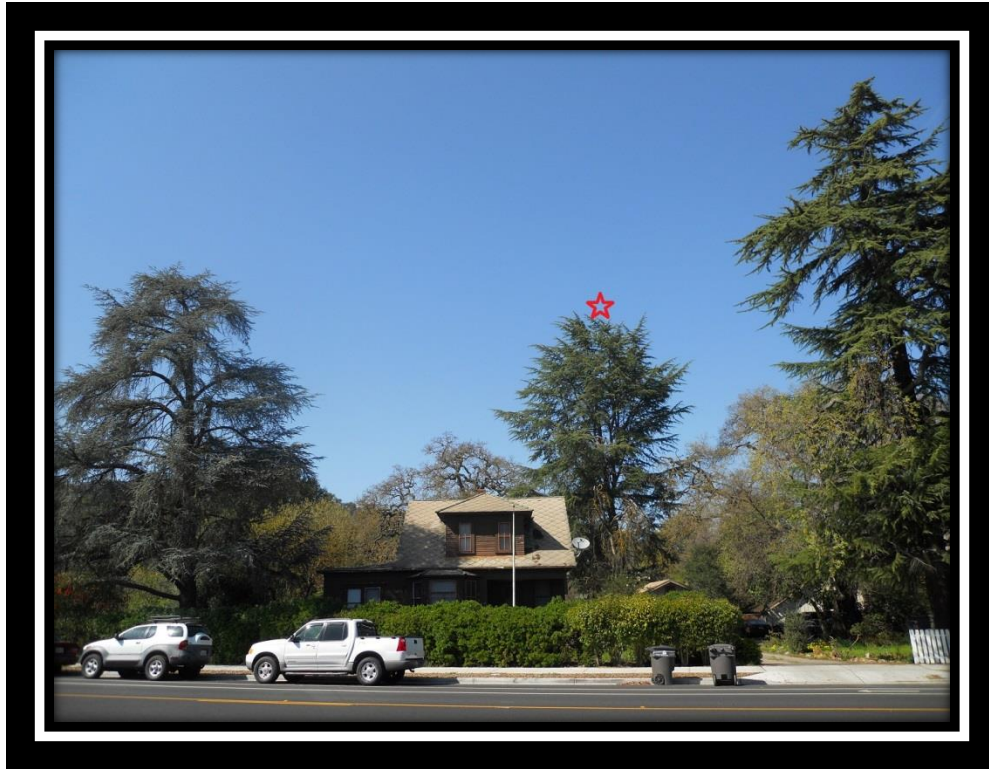
**Tree#17 Remove-Too close to foundation**

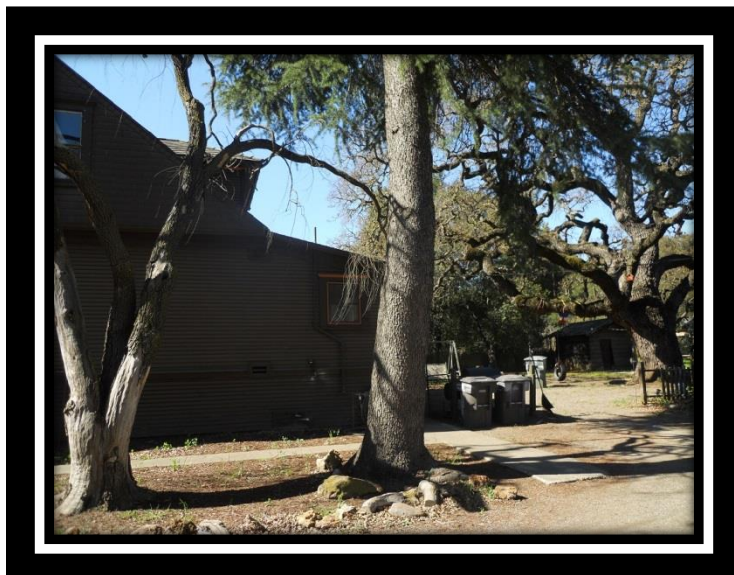
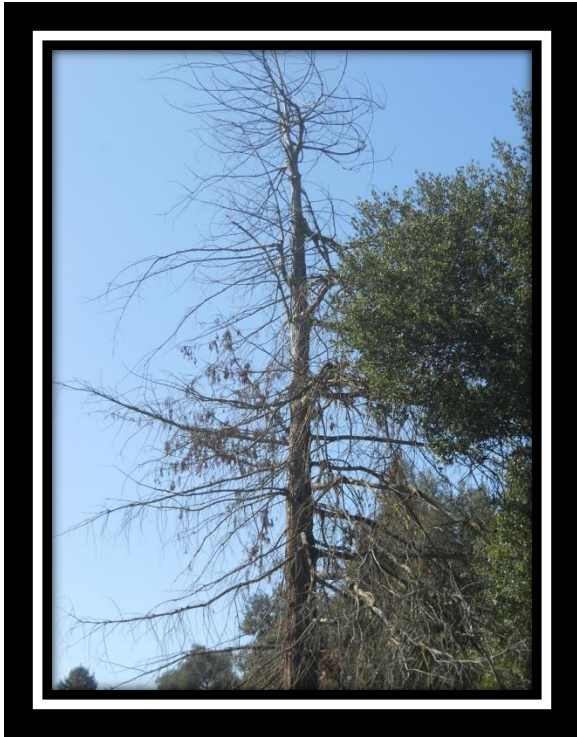
**Tree# 3 Remove- Dead**

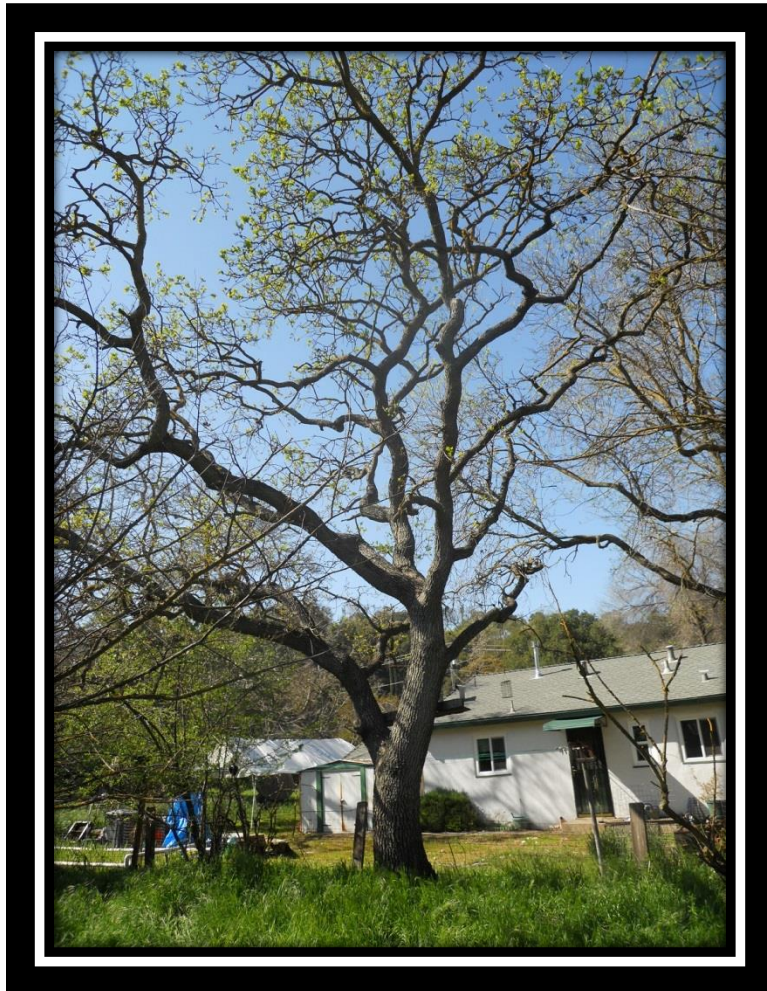
Valley oak at property line at back of property.

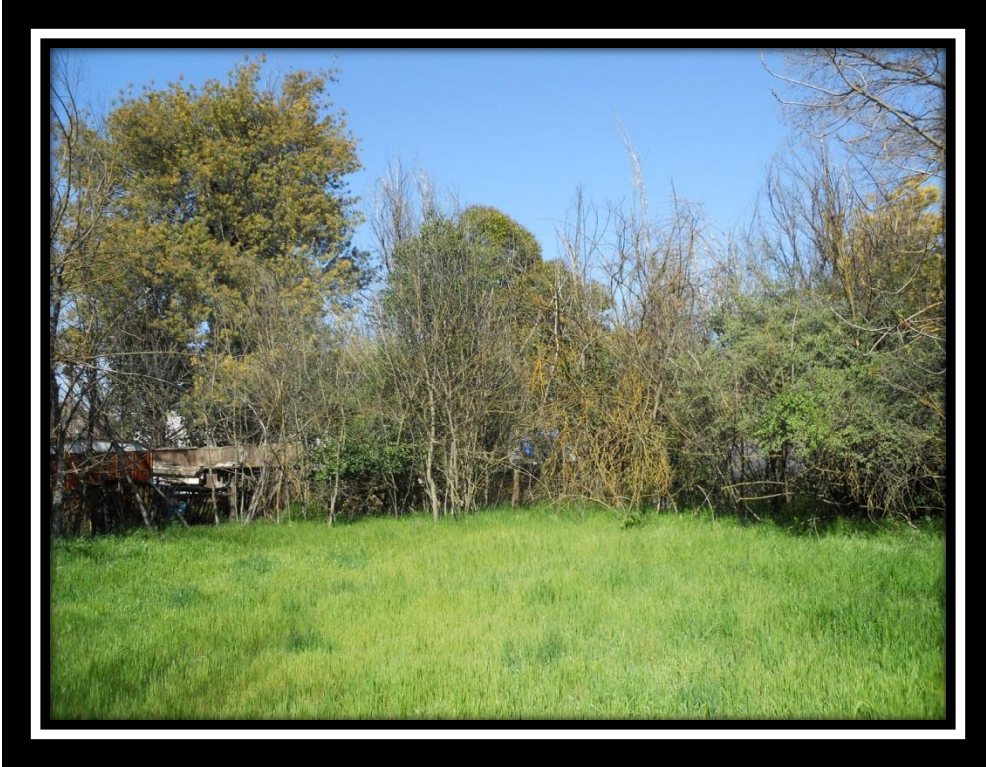
Brush and volunteers to be removed.
